Manhole Inspection Summary

Manhole # S33E__005MH

Insp Date: **11/11/08 1:44 PM**

Location Address: **8 w saratoga st**

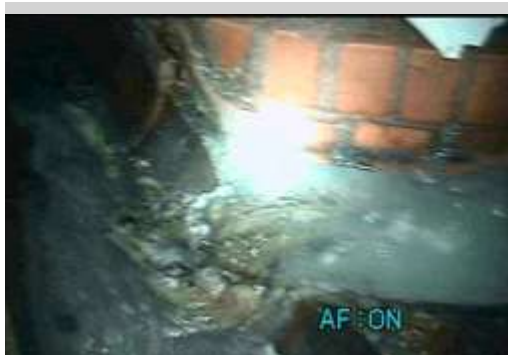
MISC

channel debris

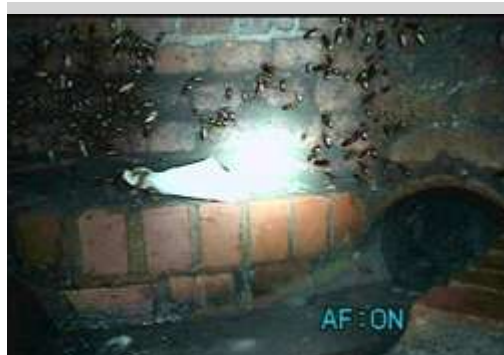
MISC

bench debris

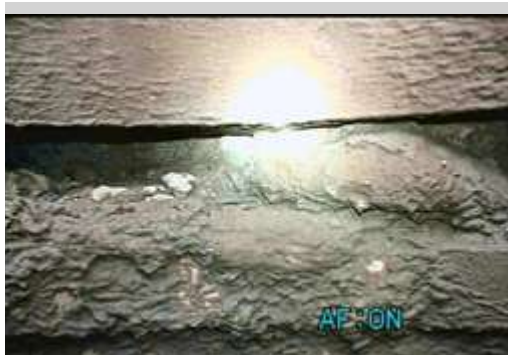
Defect 3

Condition: ☐ Sound ☒ **Cracked** ☐ Root Intrusion ☒ **Loose Brick** ☐ Deteriorated

chimney cracked loose bricks at frame joint

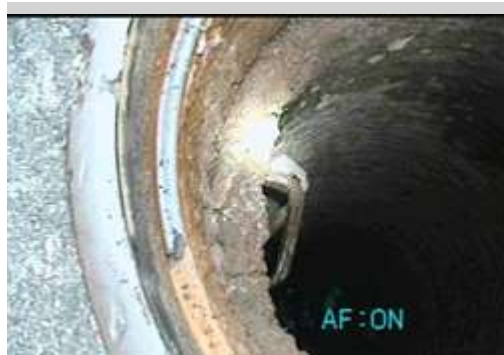
Defect 2

Offset: **2** (in.)

frame offset 2 inches

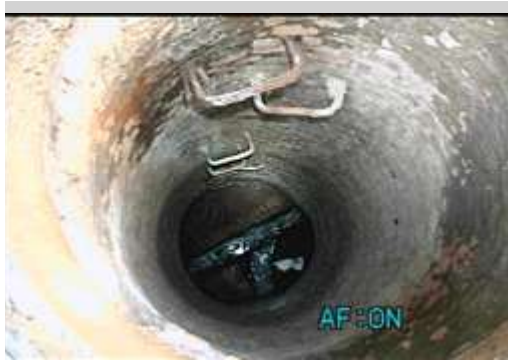
Defect 1

Count: **10** Missing: **2** ☒ **Corroded**

steps corroded/missing
